Non Destructive Testing of Drystone Walls

Warren, Laura

Awarding institution:
University of Bath

May 2018

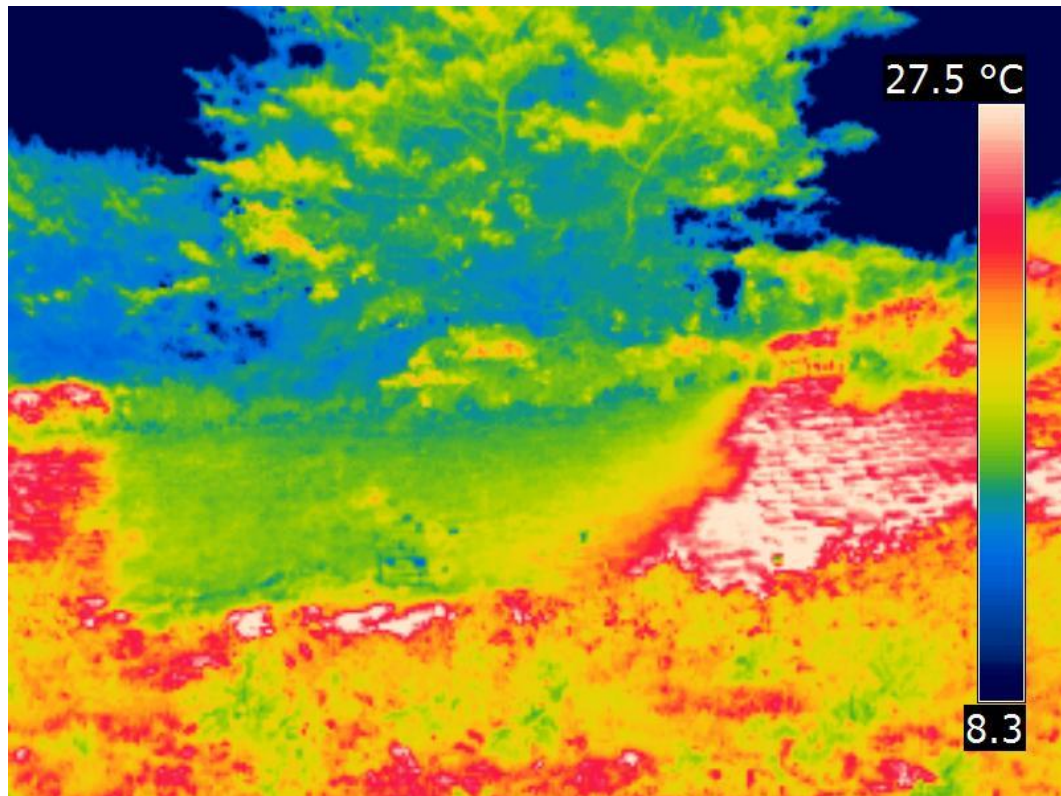
Image taken: 10:30 07/06/13; as for 08:00. Cooler points in shaded area associated with missing stone as face
